Rehabilitation of 64-Meter-Antenna Radial Bearing

H. McGinness and G. Gale
DSN Engineering Section

The performances of the radial bearings on three 64-meter antennas are presented. Explanations for the distortion of the bearing at DSS 14 are made and the repairs are described. Recommendations for future tests and action are given.

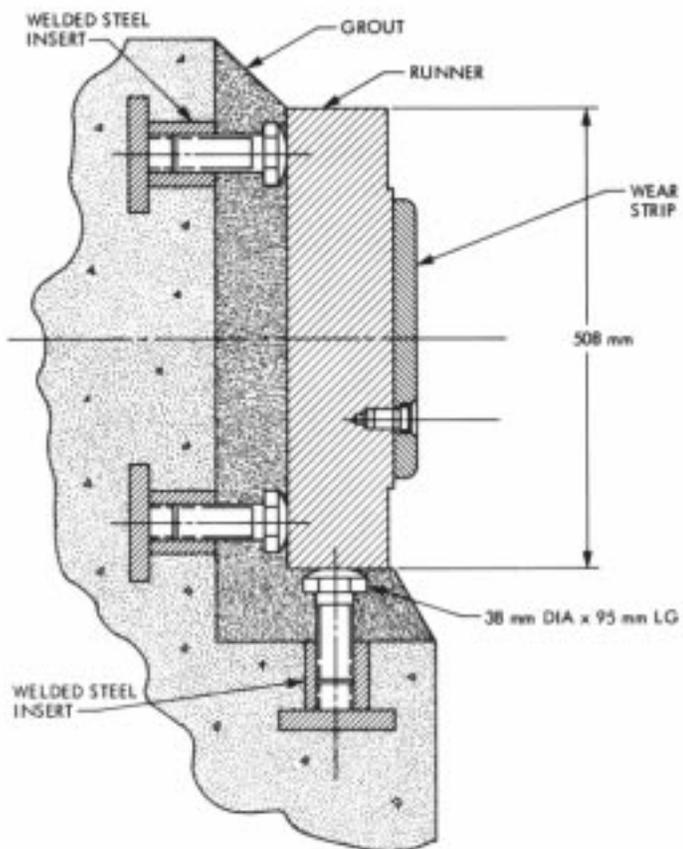
After being assembled on the ground, the track ring was hoisted up and placed around the collar at the top of the antenna pedestal. Alignment bolts, as shown in Fig. 1, were adjusted so as to obtain level, circularity, and concentricity.

At DSS 14 the grout used between the ring and pedestal was EMBECO. After the installation of the track the rest of the antenna was built over it. The details of the parts shown in Fig. 1, as well as the wheel assembly parts, are shown on JPL drawing 9437995.

Fig. 1. Cross section of runner showing alignment bolts and grout

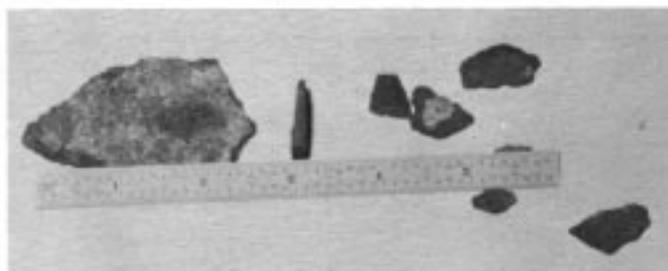
In 1977 a section of grout was cored out so that the inside of the runner could be seen. A large amount of scale was present, especially at the bottom where its thickness was 2 mm or more (see Fig. 2). It was then definite that the corrosion was caused by moisture coming into contact with the runner/EMBECO grout interface. The conical shape of the runner was judged to be due to the graduation of corrosion, varying from a very small amount at the top to an appreciable amount at the bottom. It was impossible to know what change had occurred in the runner radius, since original dimensions were not known more precisely than were given by dimensional tolerances. It could only be assumed that the conical shape of the runner was caused primarily by an outward radial displacement of its lower edge equal to the product of the measured slope and runner height. An analysis of the runner was made to determine its hoop force corresponding to the estimated amount of radial displacement. Then an estimate of the joint pin shear stresses, corresponding to this hoop force, was made. When the shear pin stress was compared to what was believed to be the breaking stress, it was judged that the margin of safety was too low. It was believed also that the corrosion on the back side of the runner would cease if oxygen were excluded from the region. Therefore the decision was made to strengthen the runner by welding the joints and to exclude oxygen by filling all voids with an epoxy cement and sealing the upper and lower edges of the runner with an appropriate substance (see Fig. 3).

Fig. 2. Scale removed from runner at grout interface, DSS 14

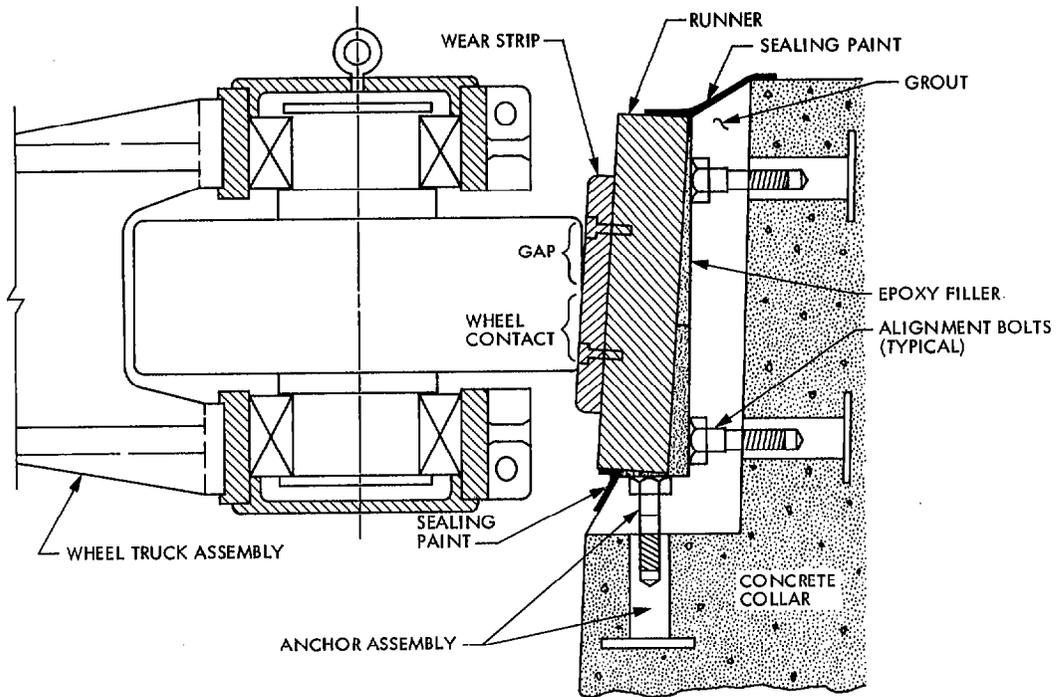
The wear strip bearing surface was not vertical but was sloped inward and upward by 0.24 degrees.

Fig. 3. Distorted runner at DSS 14; voids filled with epoxy resin

It had been decided to fill the voids behind the runner with a special epoxy resin which had been developed for filling cracks and voids in earthquake-damaged concrete structures. Since there existed a finite gap between the grout and upper edge of runner, the epoxy could enter at the gap and by elevation head pressure be made to fill all the voids, provided that a temporary seal was established at the lower edge of the runner. The epoxy filling was accomplished in 1978. The exothermic action of this particular epoxy reduces the initial viscosity enormously so that it is capable of entering hairline cracks. For this reason it may be assumed that the voids were filled. The subsequent application of a sealing paint to the outside insures that oxygen is excluded from the runner grout interface.
